Manhole Inspection Summary

Manhole # S11GG2007MH

Insp Date: **7/10/06 8:41 AM**

Location Address: **2300 BRIGHT LEAF WAY**

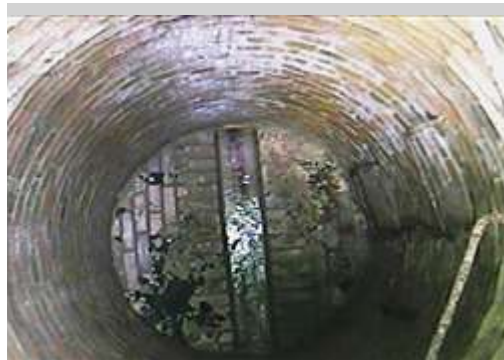
Top View

Corbel and Barrel infiltration. Corroded steps. Bench debris.

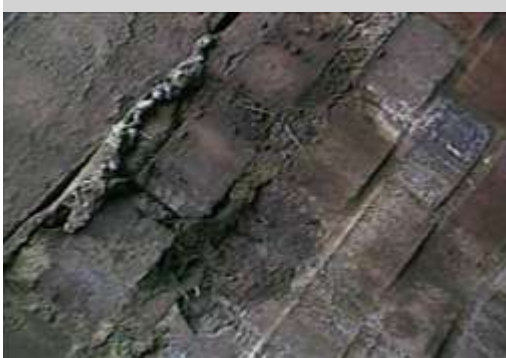
Defect

Frame leaks. Adjustment deterioration, root intrusion, infiltration.

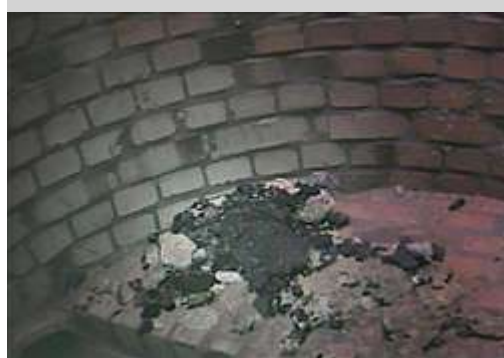
Defect

Bench debris.

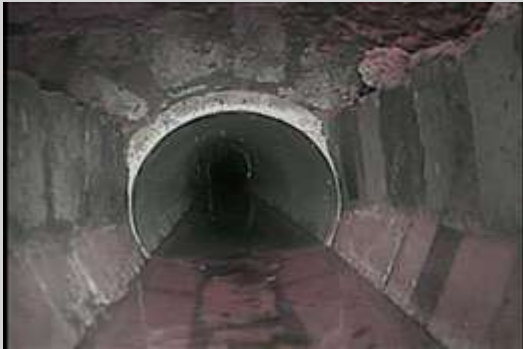
8 in. Circular Gravity Sewer Pipe Out @ 12 O'Clock

Pipe Material: **Clay** ☐ Pipe Lined

Invert Depth: **10.31** (ft.) Flow Characteristics: **Slow**

Infiltration: **None** Pipe Seal Cond: **Unknown**

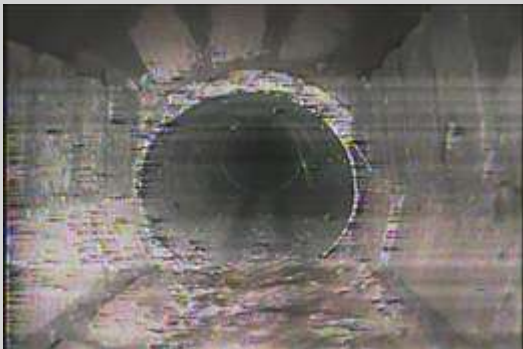
8 in. Circular Gravity Sewer Pipe In @ 6 O'Clock

Pipe Material: **Clay** ☐ Pipe Lined

Invert Depth: **10.29** (ft.) Flow Characteristics: **Slow**

Infiltration: **None** Pipe Seal Cond: **Unknown**
